**The Stormwater Coalition of Monroe County and Monroe County  
Department of Environmental Services**

Prepared for:  
New York State Environmental Protection Fund

July 2013

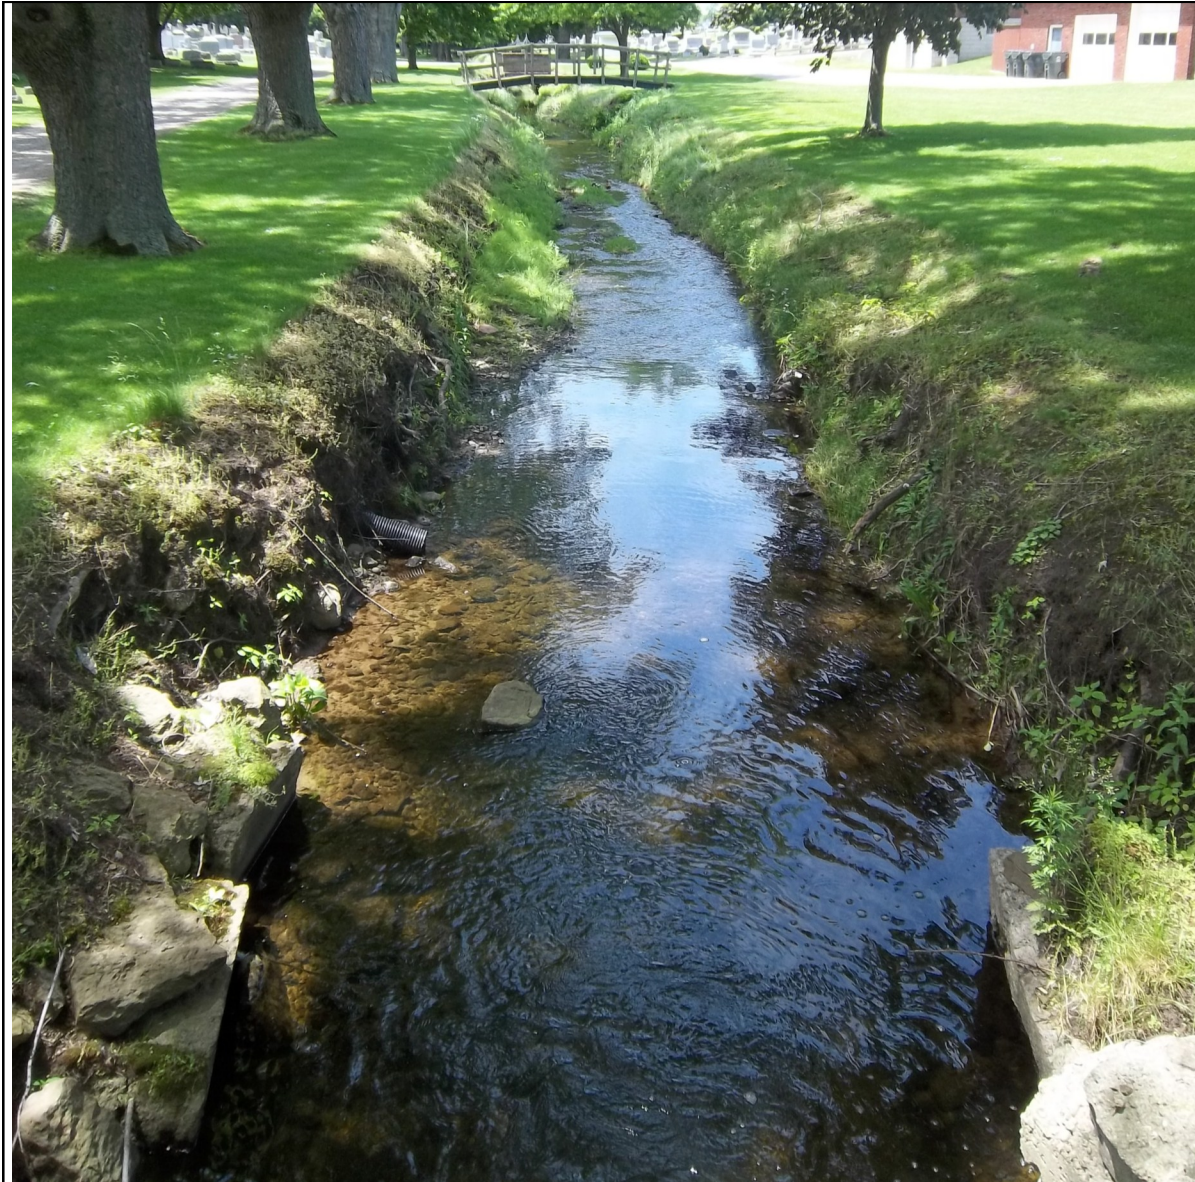
Figure 4. Eroded Streambank on Mill Creek.

**1.4.4 Streambank Erosion** There are ten reported erosion sites on Mill Creek from assessments done by the Monroe County Soil & Water Conservation District in 2001. All sites were visited and show mostly minor eroded stream banks (Figure 4).

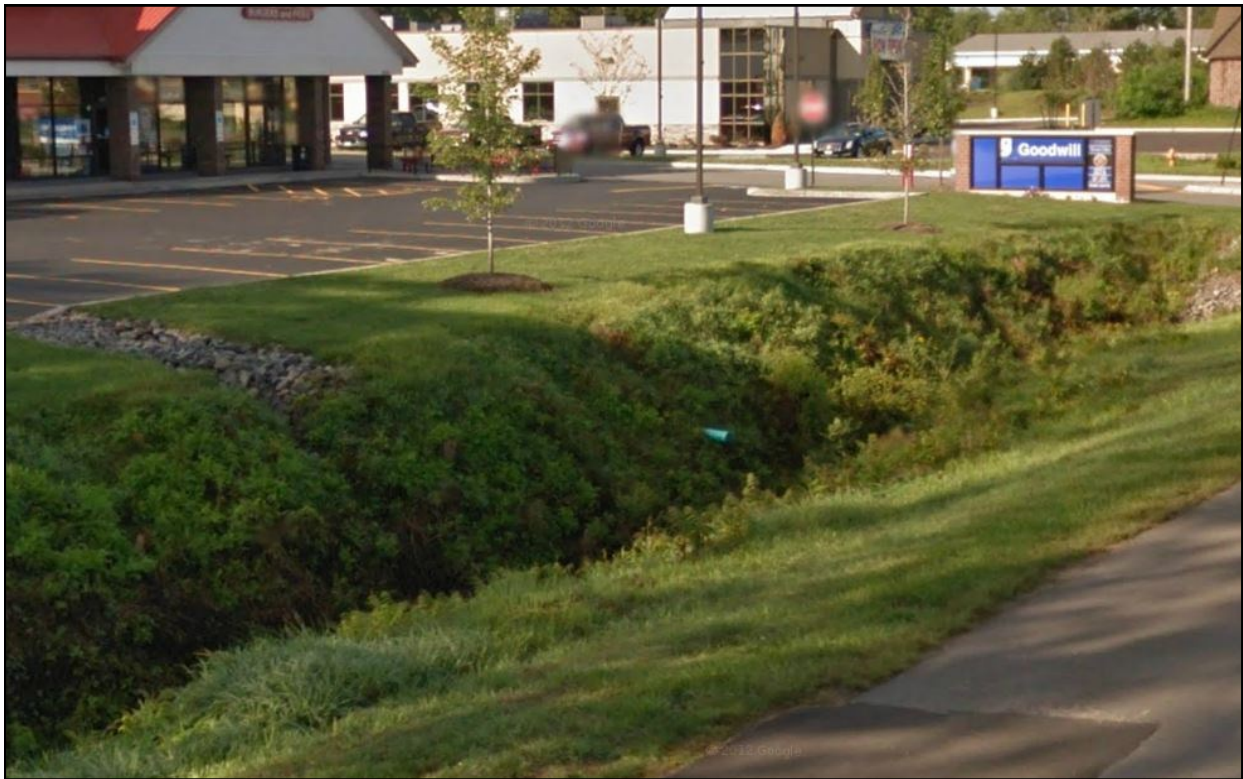
Figure 5. Mill Creek is channelized through much of length in commercial areas of Ridge Road

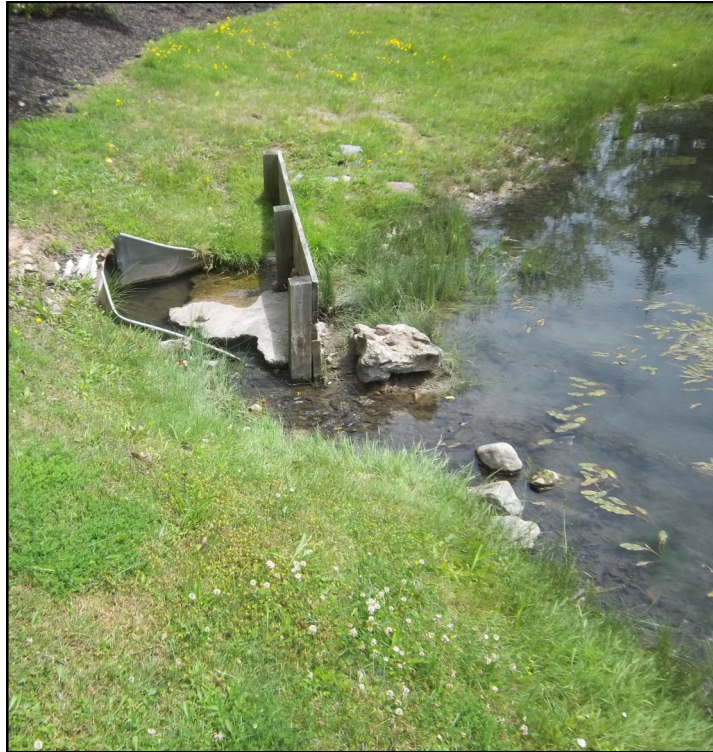
Figure 7. Existing pond's outlet structure lacks features that promote pollution removal.

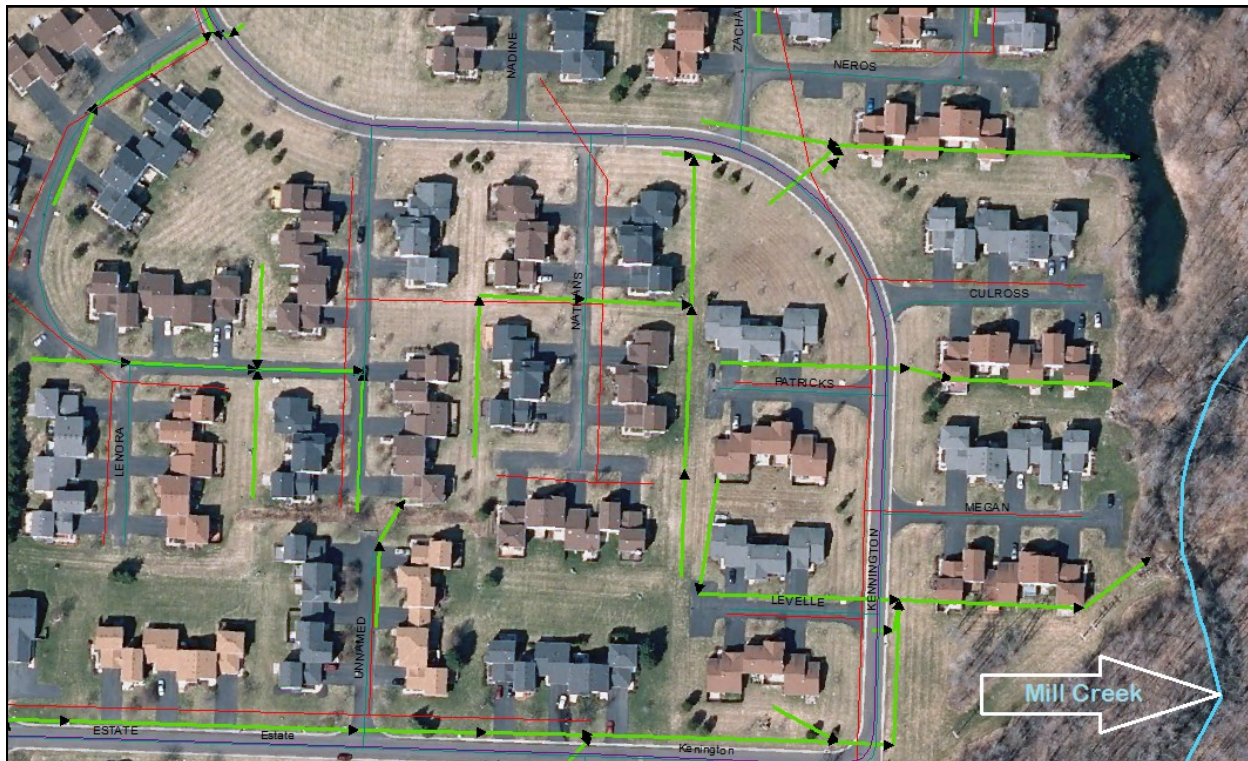
Figure 8. Potential Retrofits include GI in green space at this dense multi-family residential development from the 1970's that lacks stormwater treatment.
