Green Infrastructure Rapid Assessment Plan

Larkin Creek Watershed

August 2013

**The Stormwater Coalition of Monroe County
and Monroe County Department of Environmental Services**

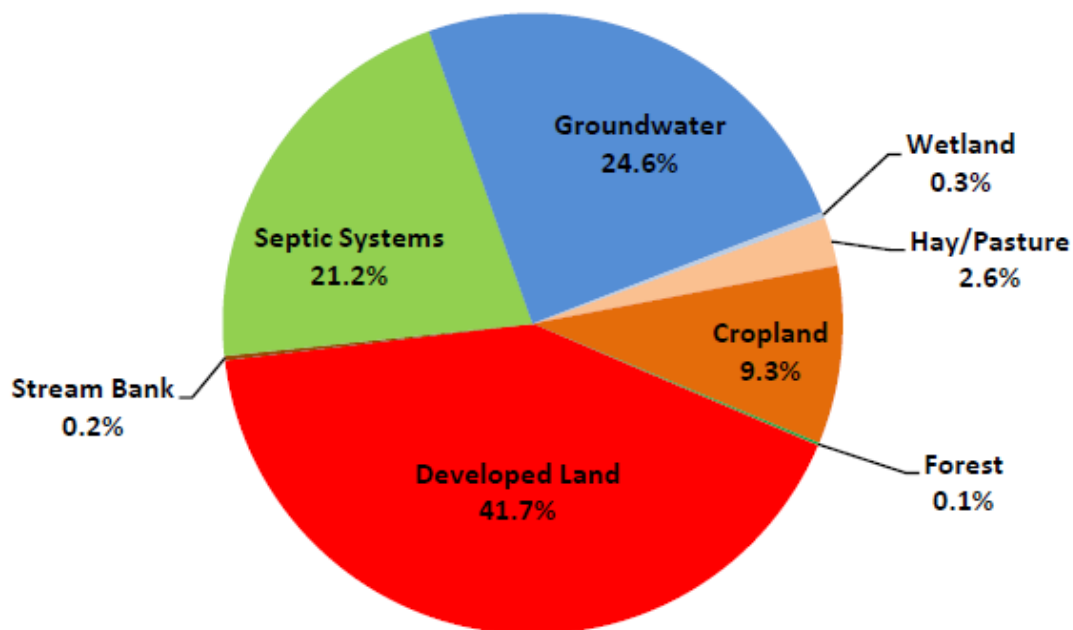
Figure 3: Estimated Sources of Total Phosphorus Loading to Buck Pond (EPA 2010)

In 2002, Buck Pond was added to NYSDEC’s “Waterbody Inventory/Priority Waterbodies List” (revised 2013, NYSDEC). This list is referred to as the “303d” list because it refers to section 303(d) of the Federal Clean Water Act which requires states to identify “Impaired Waters”, where specific designated uses are not fully supported. The 303d list identifies those waters that do not support appropriate uses and that require development of a Total Maximum Daily Load (TMDL) or other restoration strategy. The pollutant listed as impairing Buck Pond is phosphorus from urban runoff. In July 2010, a draft TMDL was developed by NYS DEC. The report modeled the sources of phosphorus and estimated that 41.7% of the load to Buck Pond came from developed land (Figure 3). In all, its estimated that 72% of the load is from anthropogenic sources. TMDL implementation was subsequently placed on hold allowing time for local stakeholders to develop a strategy to reduce loads.

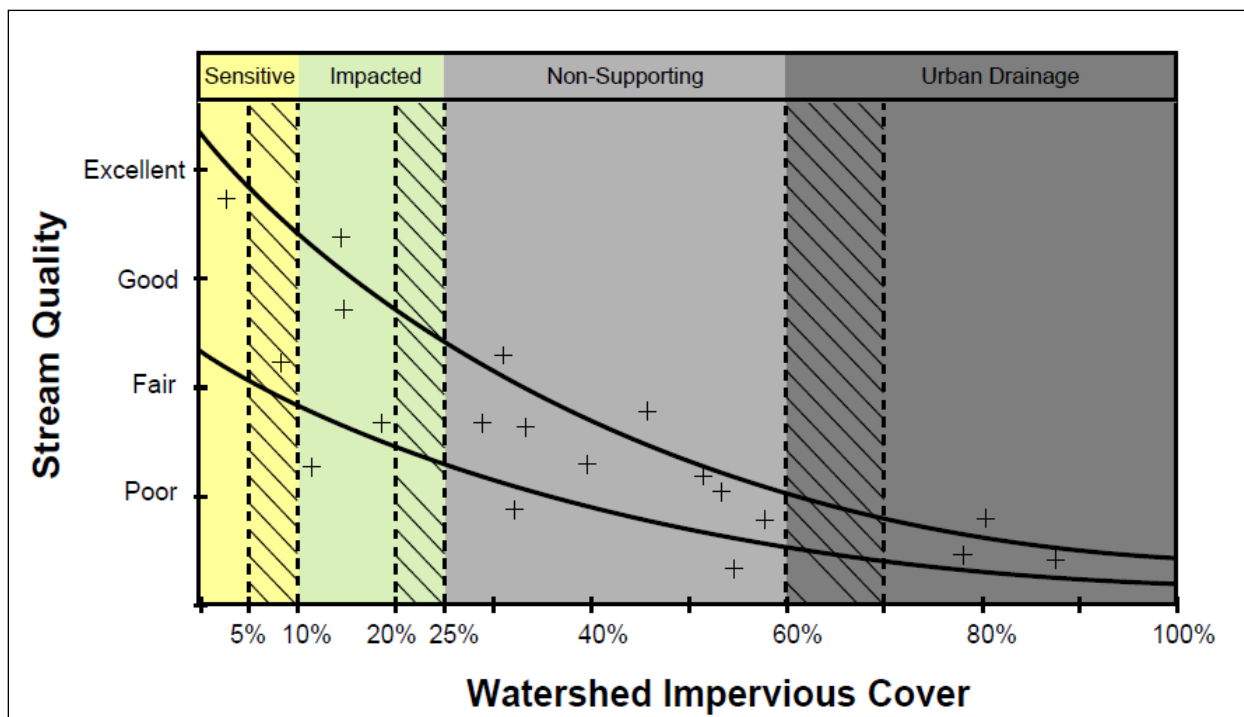
Figure 4. Impervious Cover Model

1.4.2 Impervious Cover Analysis The Center for Watershed Protection developed the “Impervious Cover Model” (ICM) using the relationship between subwatershed impervious cover and stream quality indicators to predict a typical stream’s health. It has been confirmed by nearly 60 peer-reviewed stream research studies (Figure 4) . The ICM shows that stream quality decline becomes evident when the watershed impervious cover exceeds ten percent. Larkin Creek has an average of 20 percent impervious cover identifying stream quality somewhere between poor and good with impacted aquatic life. Based on current zoning it is predicted that watershed impervious cover will increase to 25% in the next 20 years.

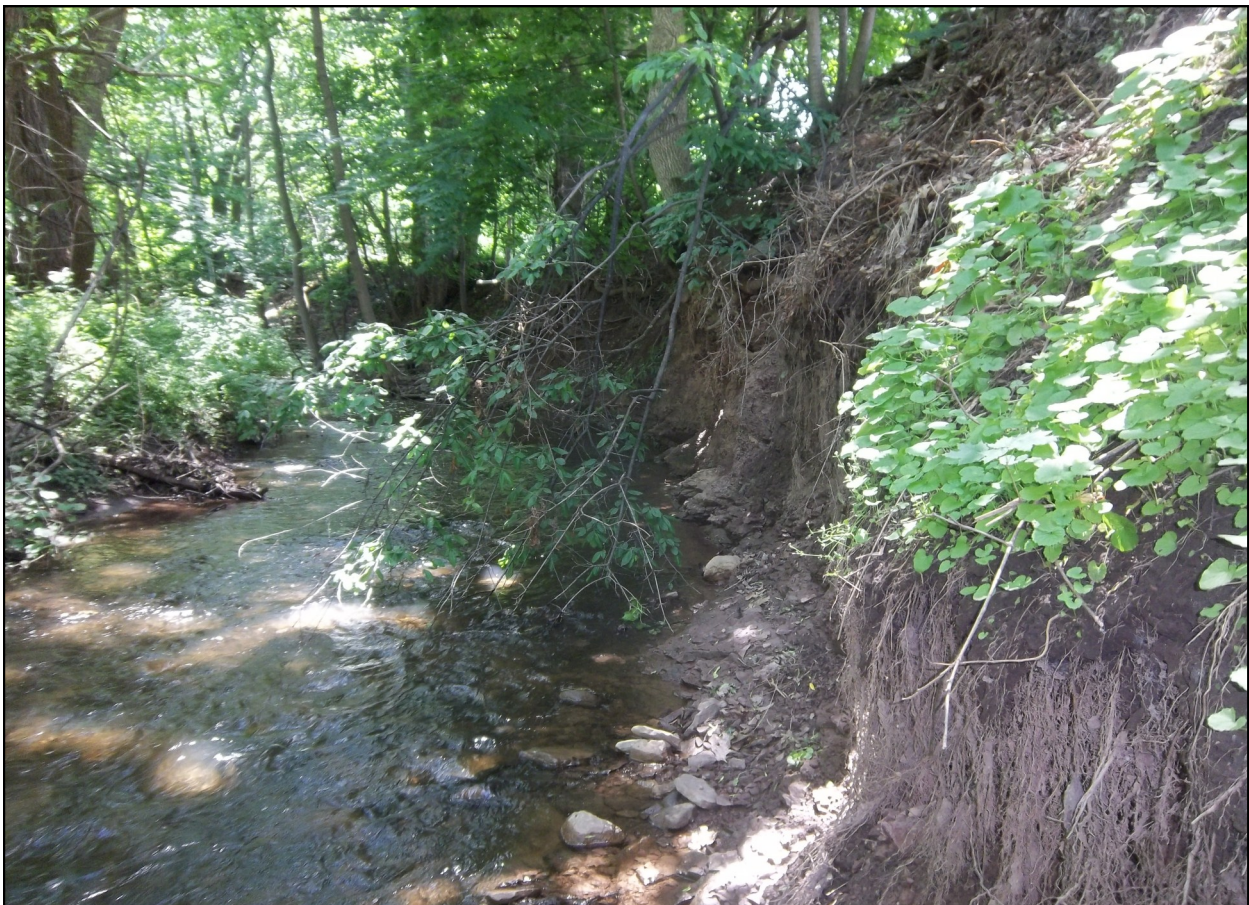
Figure 5. Eroded Streambank (just south of Latta Road crossing)

1.4.4 Streambank Erosion Staff documented and photographed many eroded streambank locations throughout the watershed and revisited sites previously assessed by the Monroe County Soil & Water Conservation District in 2001. All sites were visited and show mostly minor eroded stream banks however, several showed significant erosion rates and likely contribute measurable sediment loads to the creek (Figure 5).
